IMPORTANCE OF PAST DISASTER RECORDS -A CASE STUDY OF ITS APPLICATION AFTER THE NOUBI EARTHQUAKE IN GIFU-

^aDepartment of Architecture, National Institute of Technology, Gifu College, Japan

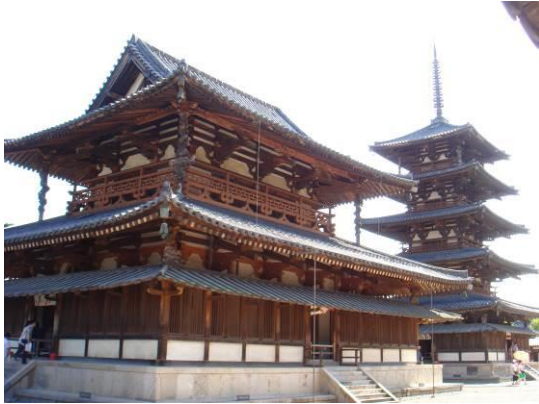
Figure 7. Horyu-ji Temple

On the other hand, as pointed out by Nishizawa ([6]) when the disaster is recorded and analyzed it is necessary to pay attention to not only "What building broke." but also "What building remained.". Figure 7 shows Horyu-ji Temple in Nara, one of the oldest wooden buildings existing in the world that constructed over 1000 years ago. Figure 8 shows the Main Hall at Shinryu-ji Temple in Gifu that constructed about 10 years before the Noubi Earthquake. In the background of survival from various natural disasters, there are technologies and devices that have been cultivated in the history. Although it does not refer in detail in this study, effect of traditional construction method is pointed out as the reason (e.g. [9]).
